JENNINGS POND DAM

(NDI I.D. PA-0891

PHASE I INSPECTION REPORT

NATIONAL DAM INSPECTION PROGRAM

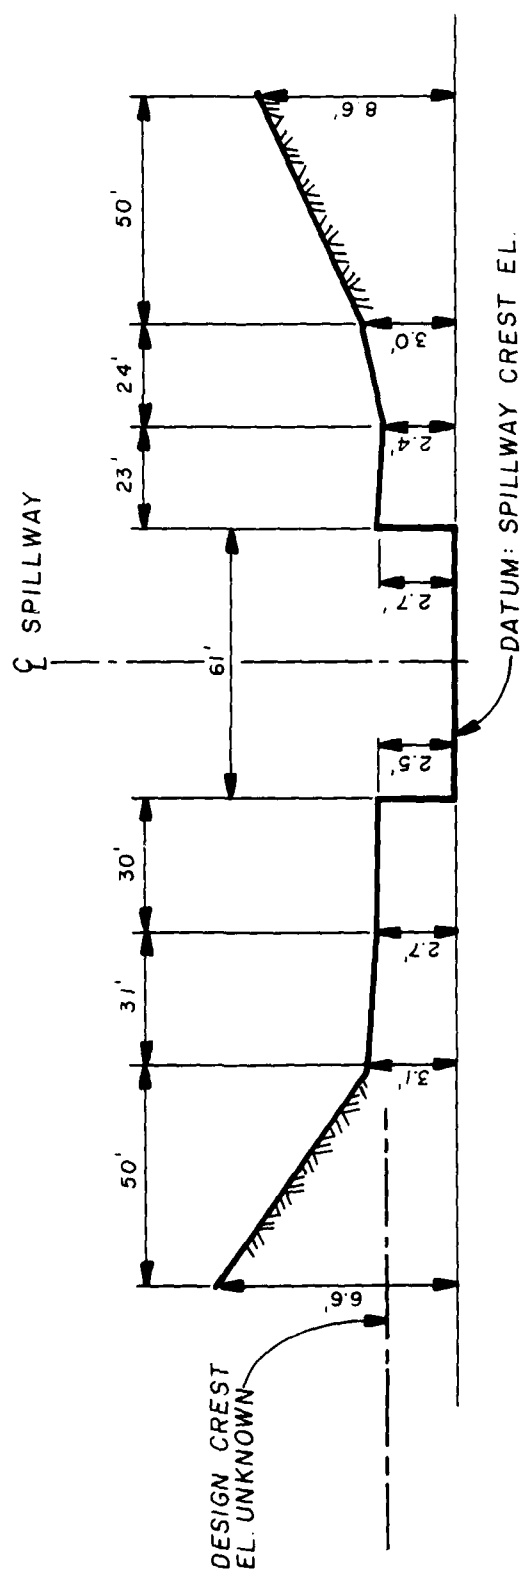
# DAM CREST PROFILE (LOOKING DOWNSTREAM)

The crest of the dam was surveyed relative to the spillway crest elevation and it was found to be relatively uniform. The crest profile is illustrated in Plate 3.
